DS3112

TEMPE T3 E3 Multiplexer

REVISION C1 ERRATA

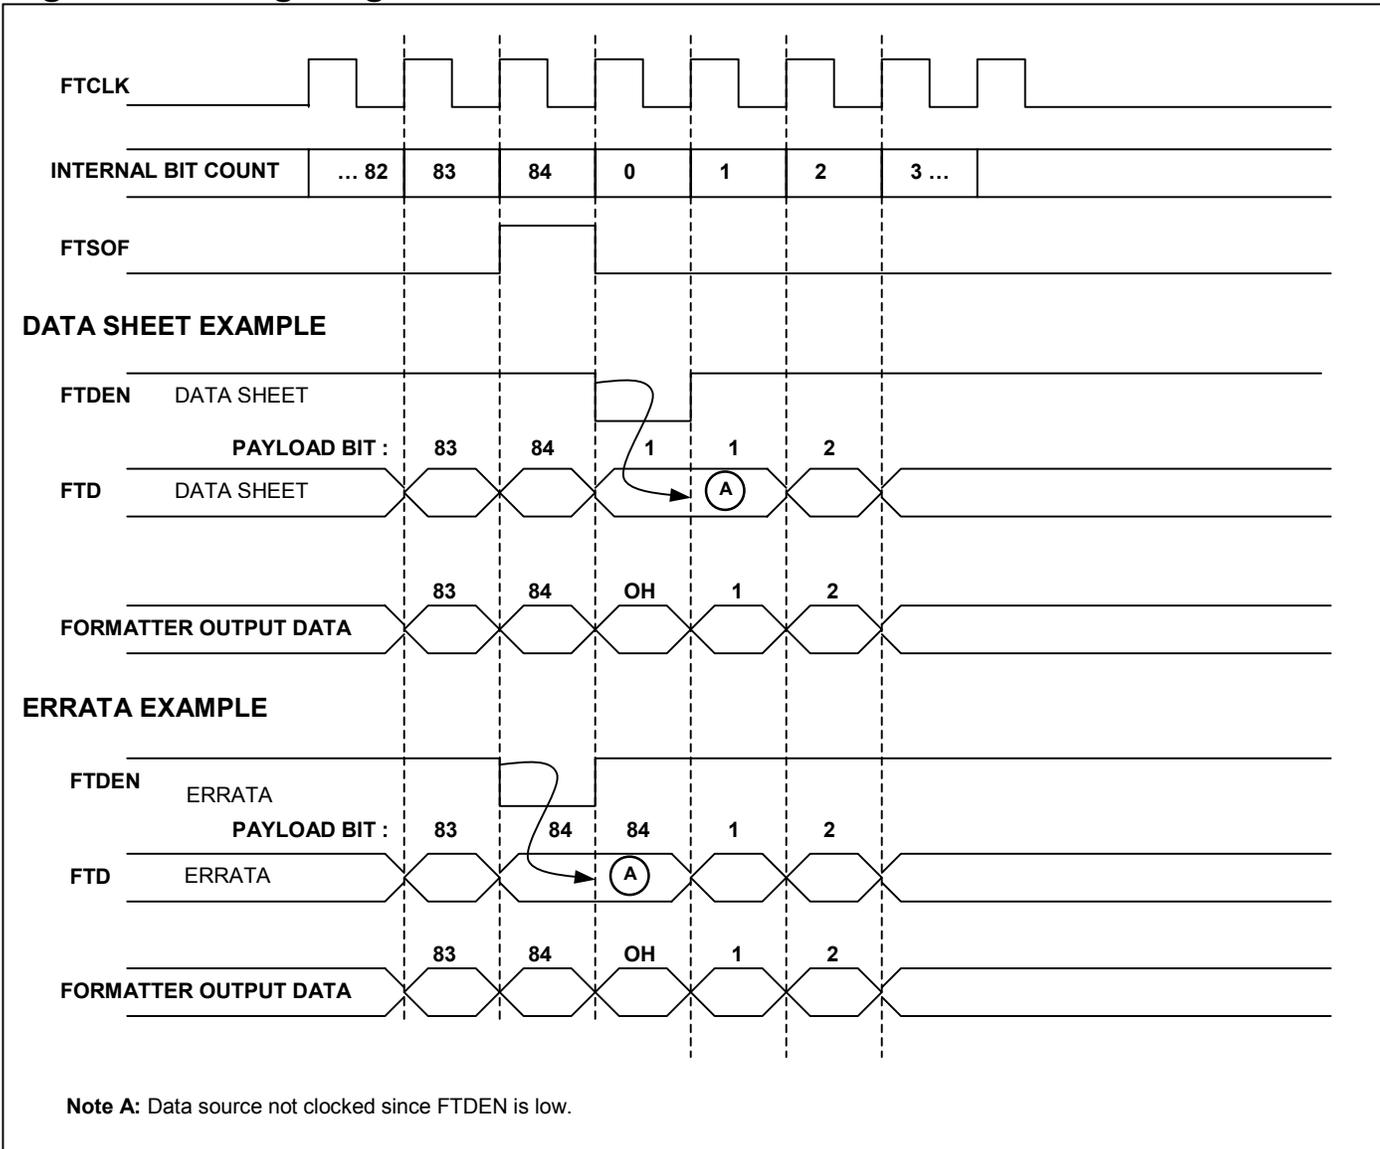
Figure 1. Timing Diagram

The FTDEN output pin (T3/E3—transmit formatter serial-data enable) pulses one clock cycle earlier than specified in Figure 2.4A of the DS3112 data sheet. This occurs in T3 mode only. FTDEN is early for both data-enable and gapped-clock modes of operation. This only affects unchannelized T3 operation; channelized T3 and E3 are not affected.

This erratum has no effect on the output data stream. Figure 1 shows that whether FTDEN pulses per the data sheet or one cycle early, the formatter output data is the same. The overhead bit is properly inserted between payload bit 84 and payload bit 1. The example in Figure 1 depicts the DS3112 where FTDEN is configured as a data enable. The gapped clock case is identical.

Use an external flip-flop to delay the FTDEN signal one clock cycle.
